Wilkinson Hi-Rise

Chute Door Replacement

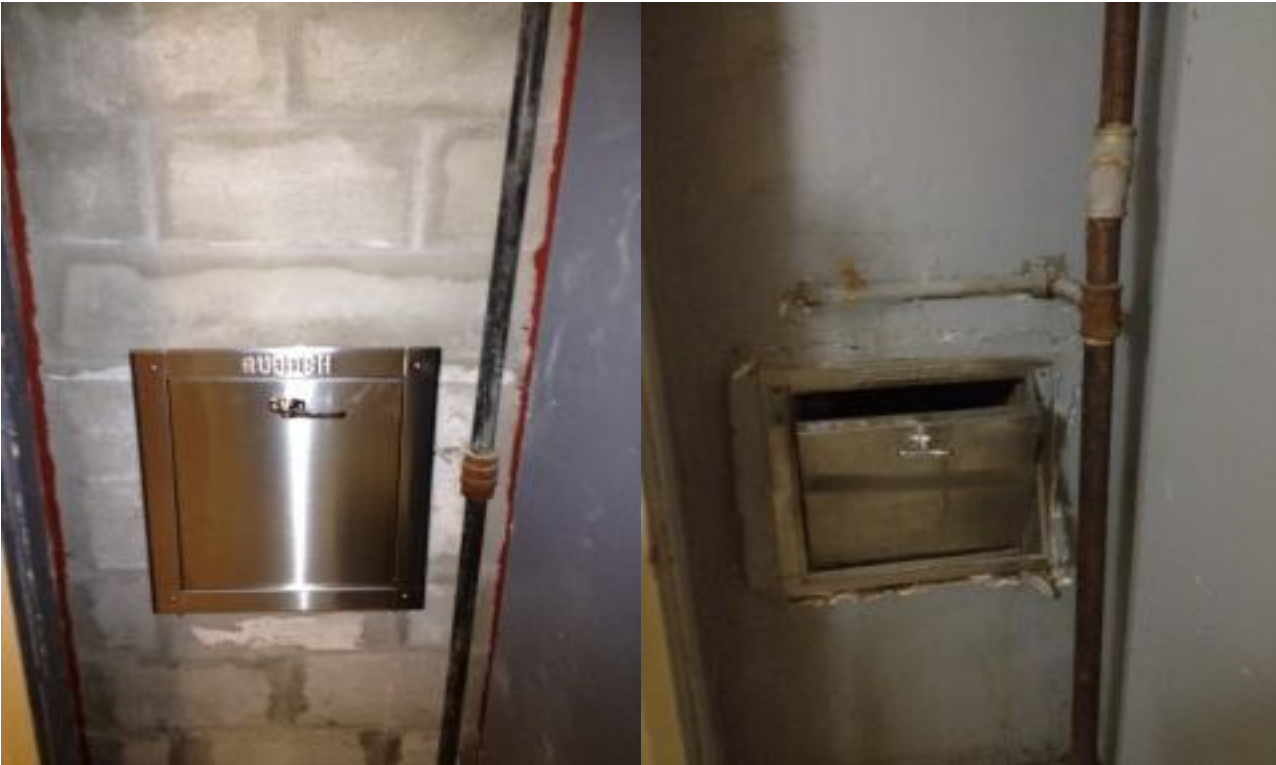
NEW 15" X 18" DOOR W/ TRIM SET

EXISTING 30 YEAR OLD BROKEN DOOR

AFTER

BEFORE

Wilkinson Hi-Rise offers a full selection of replacement trash chute doors to match almost all existing door situations. The example on the other side of this brochure depicts a horribly broken 30 year old existing trash chute door made by another manufacturer that was badly rusted internally, did not self close and latch to meet fire inspection requirements, and was missing a stainless steel trim border. Wilkinson replaced this door with our Model WLR (Wilkinson Large Replacement) door in a 15" x 18" size to match the existing opening size. We can guarantee a satisfactory retrofit installation by checking the following prior to ordering a replacement door:

Wilkinson Hi-Rise takes great care to remove surrounding wall construction (masonry, drywall, etc.) to accommodate the new door and frame. Many times we need to cut the chute throat metal to allow the new door to fit "flush" to the existing wall partition due to design differences. These conditions are not always forecast but Wilkinson Hi-Rise always stands behind the price quoted to the customer no matter the situation. The area is cleaned up thoroughly after installation and the door is lubricated and tested and ready for use prior to our departure. We suggest that the customer apply a bead of caulk to the final installation as required to match the existing paint color of the surrounding wall.
