Wilkinson Hi-Rise

TRASH CHUTE OFFSET & DUAL BLADE GUILLOTINE

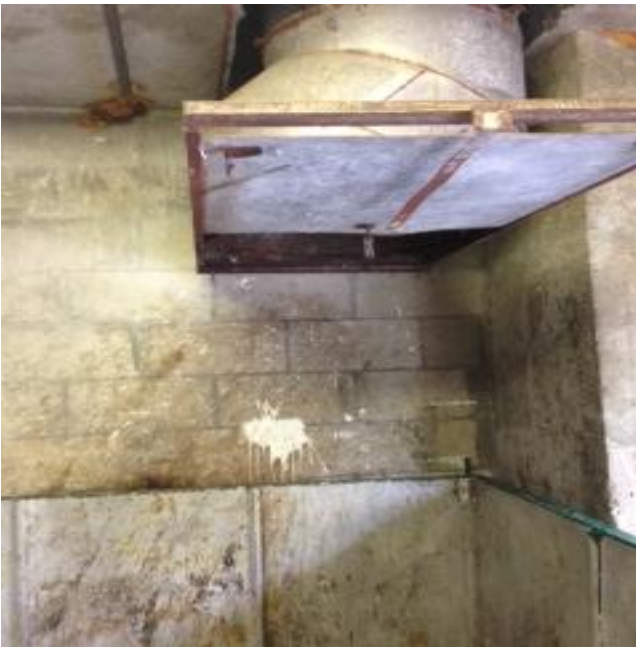
BEFORE

WALL SPLATTER (CHUTE TOO HIGH)

The “BEFORE” photo above depicts 1) wall splatter from falling waste using incorrectly designed trash chute that is too high above the waste container 2) broken “guillotine” assembly and 3) rotted out trash chute offset section.

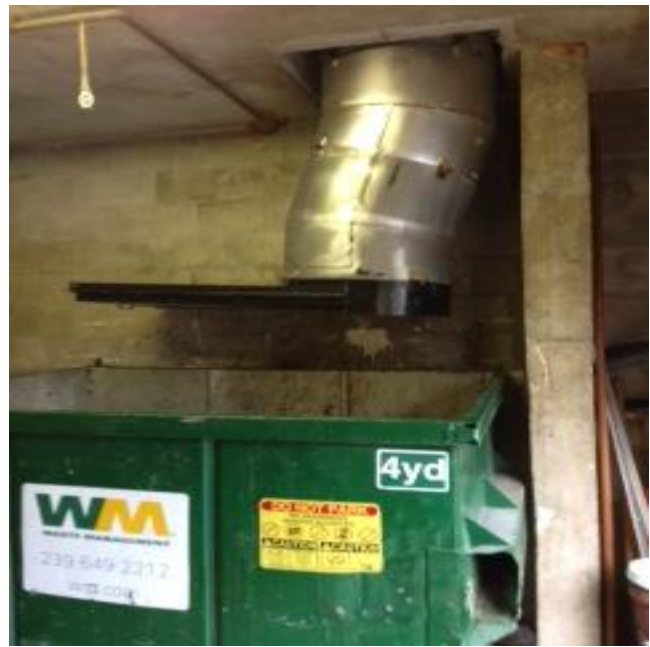
AFTER

DOUBLE OFFSET W/ DUAL GUILLOTINE

The “AFTER” photo above includes the solution provided including 1) double trash chute offset sections (15 degree), 2) new dual blade guillotine, and 3) lower chute elevation to eliminate wall splatter & unhealthy condition.
